Chegutu Master Plan

Report of Study

Chegutu Municipality

Arup Zimbabwe

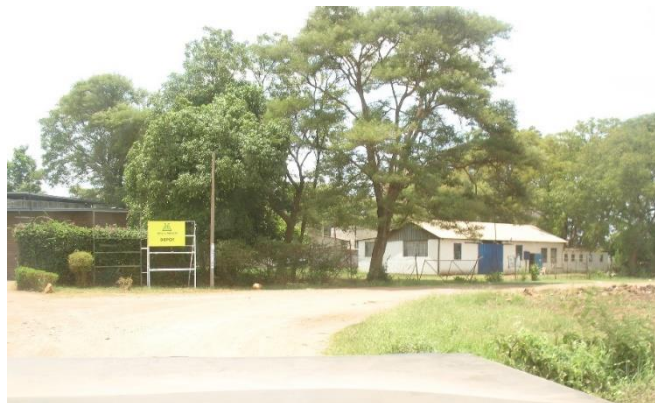
Figure 6: Vegetation in one of the low density areas in Chegutu

The vegetation in Chegutu has largely been cleared due to several ongoing human activities in the Study area. This is especially so in the high density areas to the north of the town. The situation is slightly different in the low density areas where natural vegetation is still found in residential areas. (See Figure 6).

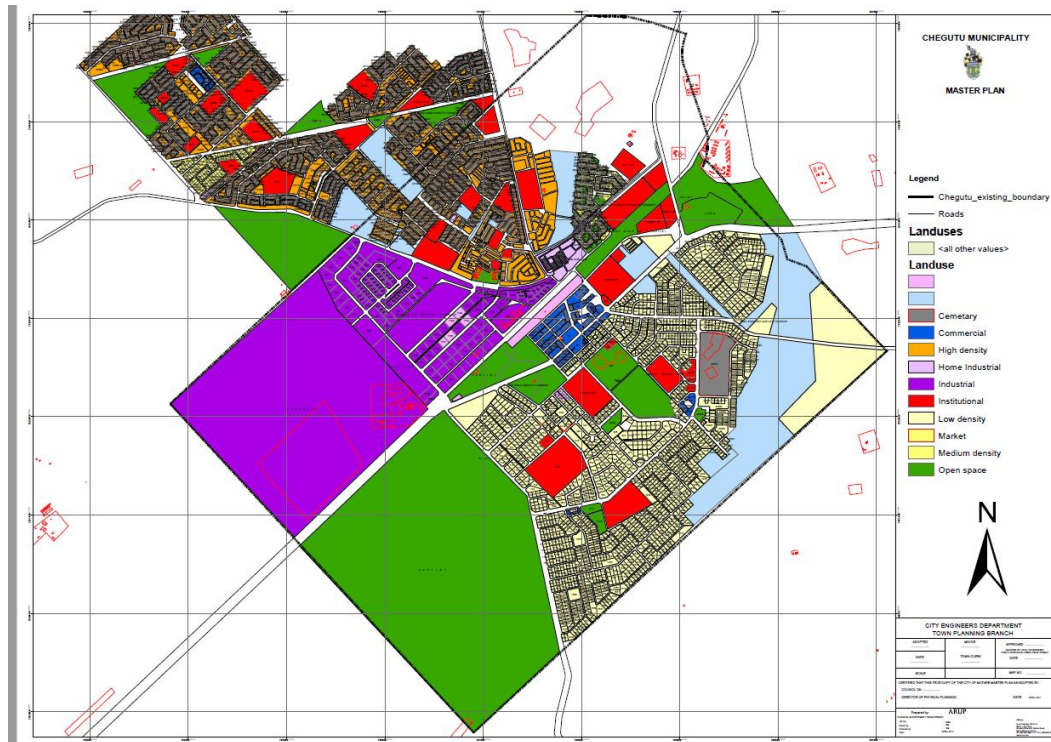
Figure 10: Distribution of Main land Uses in Chegutu Municipality Area

- (c) There is some land (92.7ha) for industrial development, mainly in Ward 2 (to the west of Bulawayo Road).
- (d) Land for commercial development is mainly concentrated in the current Central Business District Area (CBD) and several shopping centres in the Residential Areas. In the CBD, although land is generally taken up, actual coverages are low and hence the need for densification to maximize on the utilization of space.

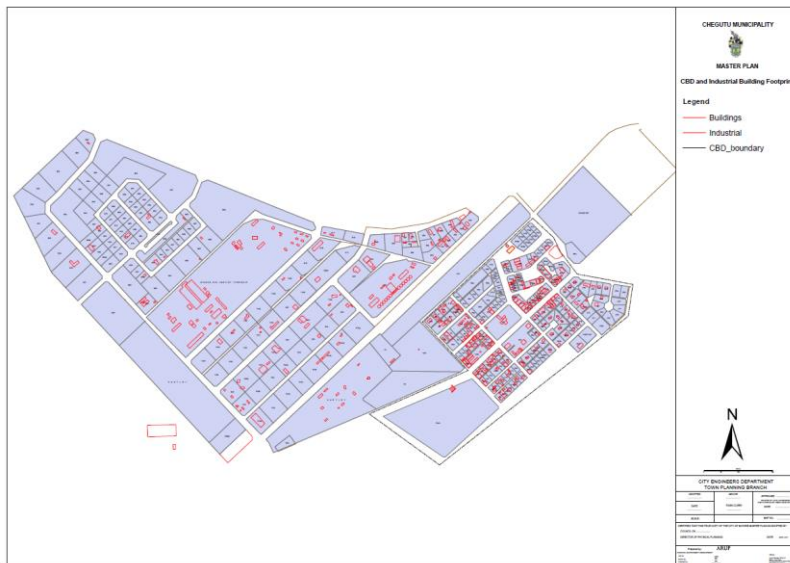
Figure 12: Building Coverages Map for Chegutu CBD

In terms of space utilization, the building coverages are low, as shown on Figure 8 as well as detailed on **Appendix 1**.

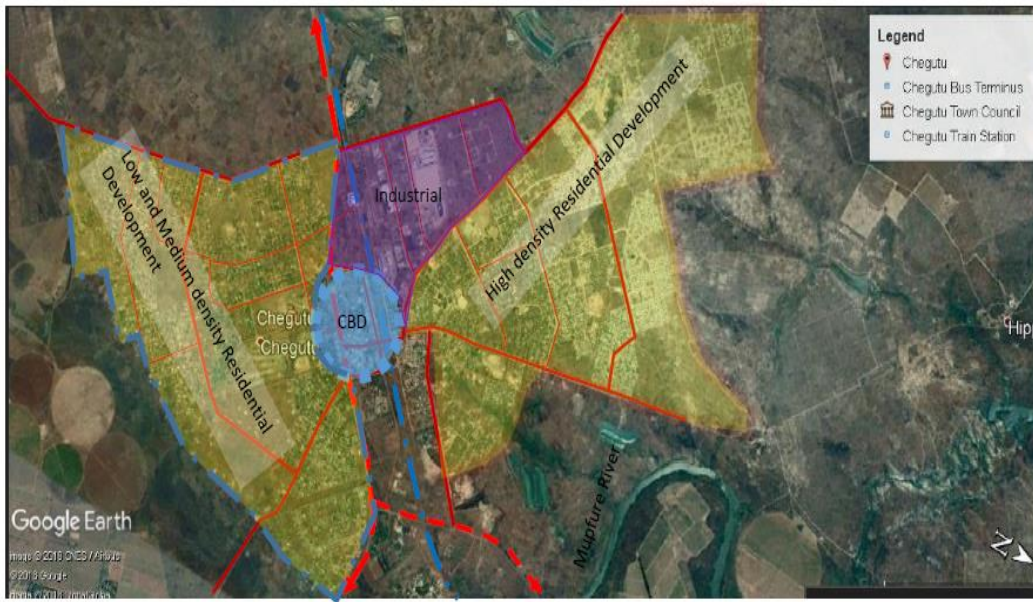
Figure 13: The Urban Structure of Chegutu Town

In terms of the urban structure, Chegutu is a Uni-Nodal, with a clearly defined central node (CBD) and residential sectors to the east and west of the CBD, including an industrial sector to the west of the main Bulawayo –Harare road. These sectors are linked to the CBD by several arterial roads/linkages as shown in Figure 8. In terms of local business commuting trips, this implies that most trips originate from residential areas in the morning and terminate in the areas around the CBD/Industrial area in the mornings and the reverse is true for the evening trips.

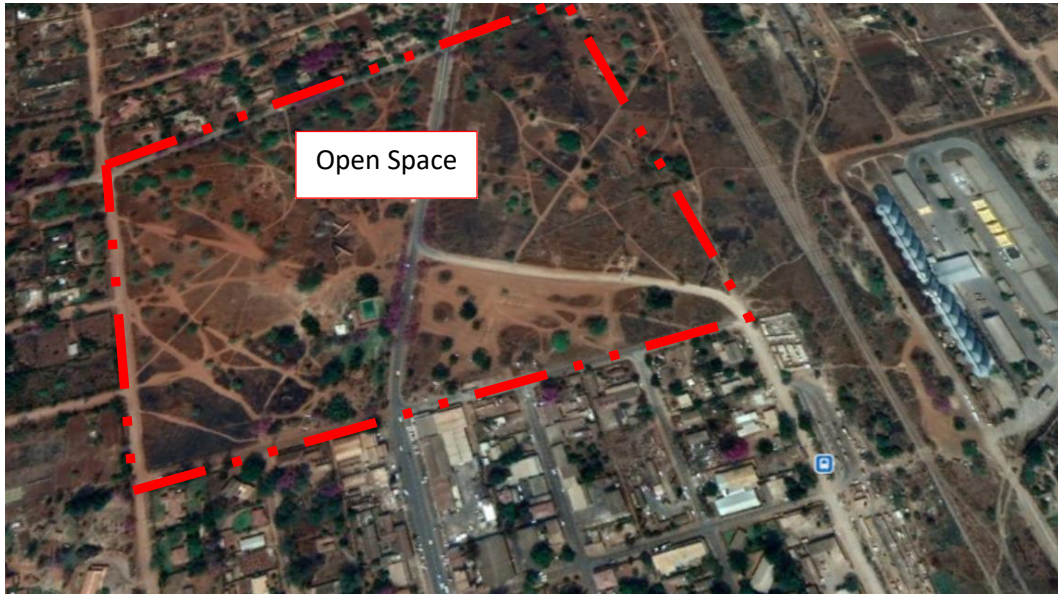
Picture 3: Aerial View of the Open Space in Chegutu CBD

The Open space in the swimming pool area is largely neglected and evidence points to progressive deterioration of this strategically located facility (See Picture 3).

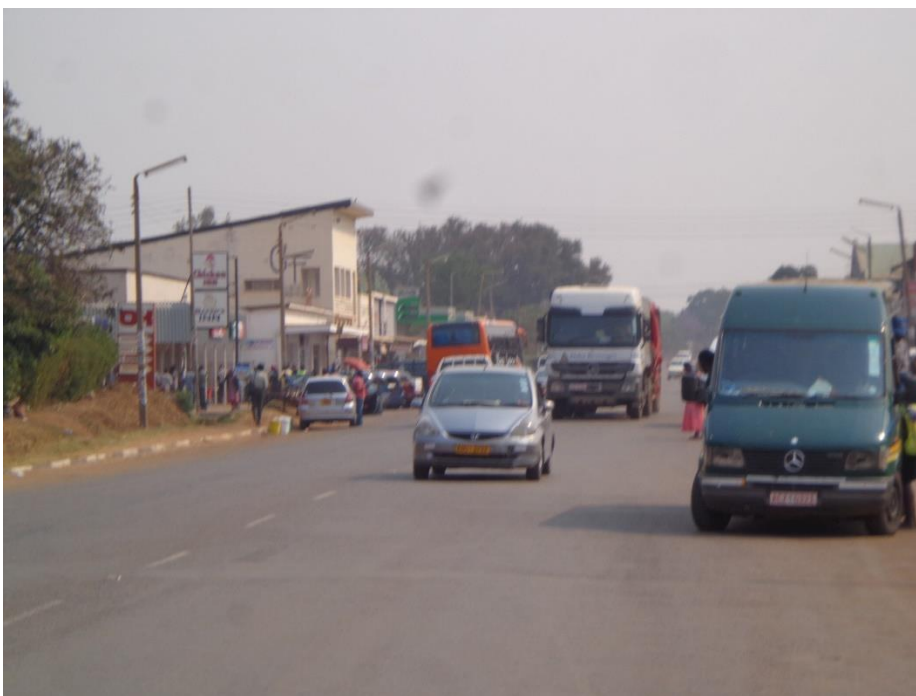
Picture 4: A section of the busy Harare -Bulawayo road)

The Bulawayo road passes through the center of Chegutu's CBD and carries high volumes of traffic at peak periods. Exhaust fumes during peak periods result in localized deterioration of air quality to affect people with shops and offices along that section of the town.

**Note the evidence of exhaust fumes behind the trucks

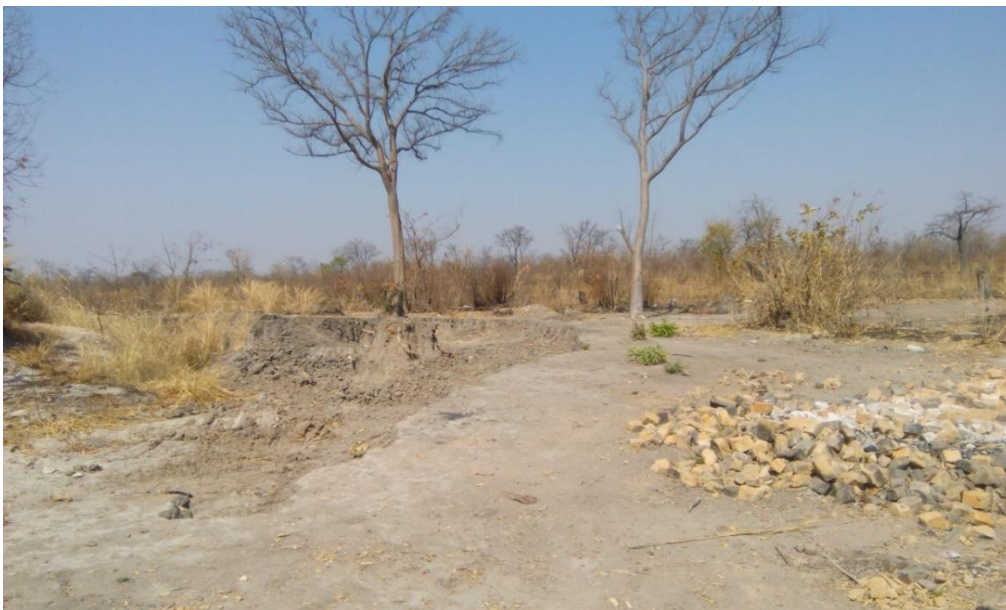
Picture 5: Sand abstraction for brick moulding in Ameva

The basic material used for brick is naturally occurring clay. Several sites for informal brick making were observed in Ameva and pose a danger to the environment (deforestation and gully formation) since the activity seems not regulated.

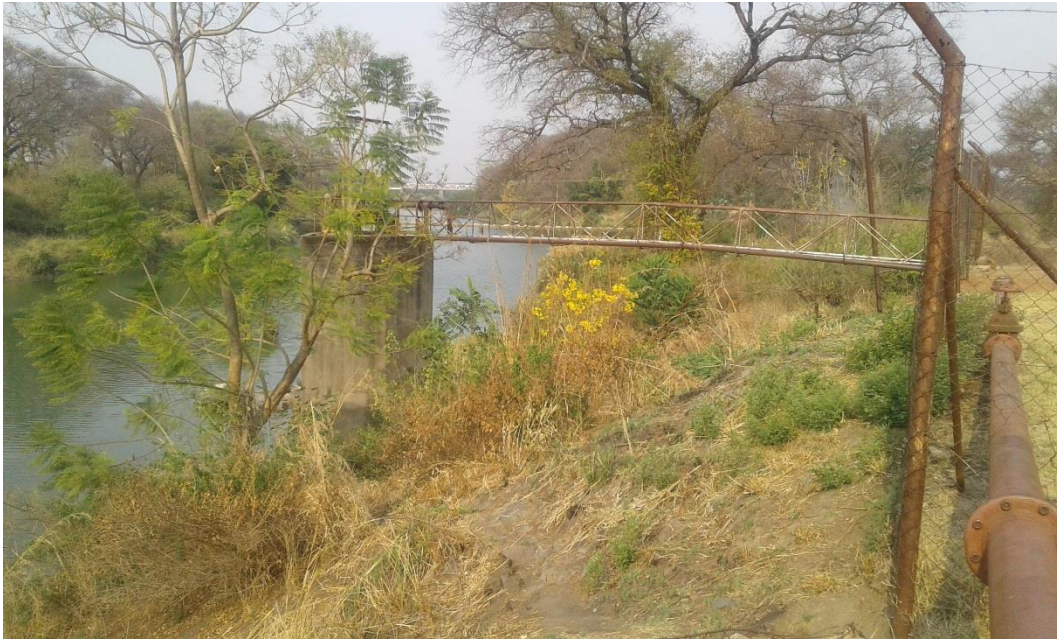
Picture 10: Mupfure Raw Water Abstraction Plant

Two AC pipelines diameter 300mm and 225mm deliver raw water to Chegutu Water Treatment Plant (WTP).

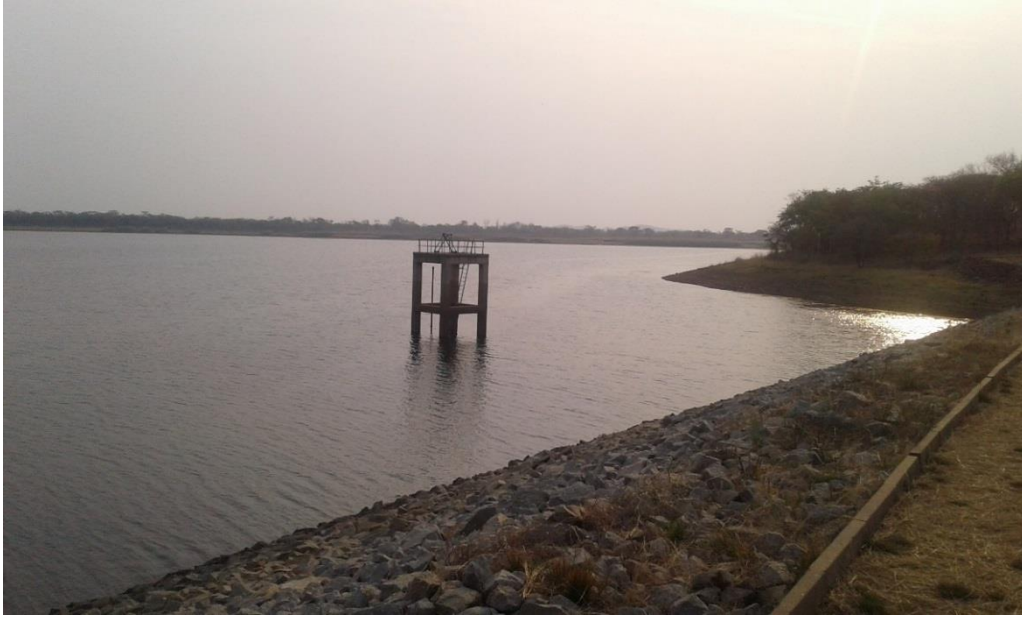
Picture 11: *Clifton Dam*

The pump station at Clifton is operating below its design capacity although it was reported by the bailiff present that recent upgrades had been made.

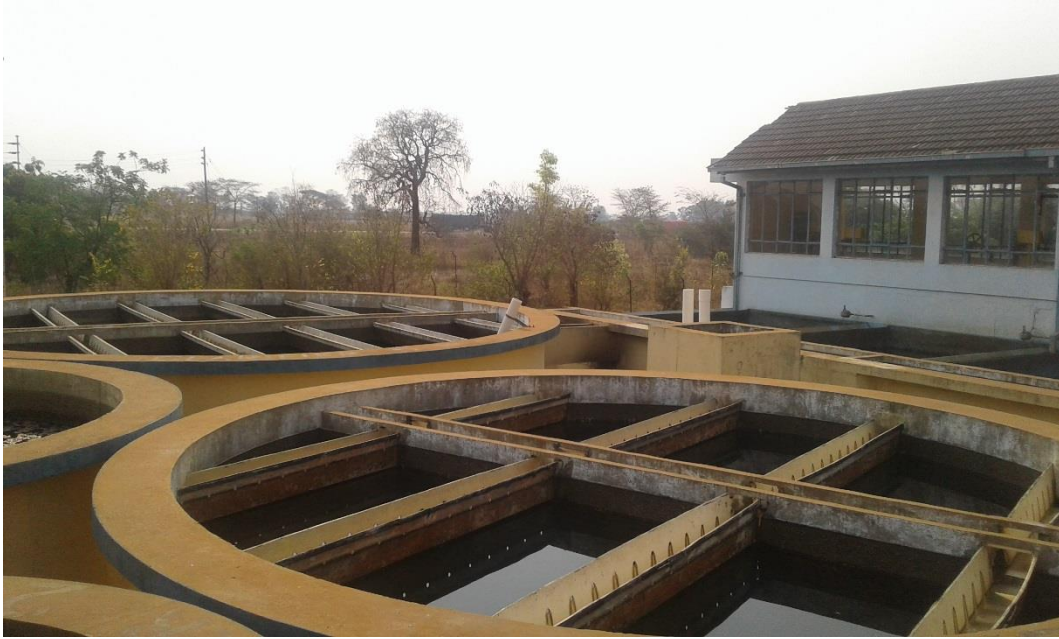
Picture 14: *WTP Circular Clarifiers*

The treatment plant is reported to be operating below its nominal design capacity of 12,000m³/d. The tables below outlines the various existing infrastructure component of Chegutu WTP.

Rectangular Clarifiers (Sedimentation) tanks	2 No	Upward flow sludge blanket
Circular Clarifiers (Sedimentation) tanks	6 No.	Upward flow sludge blanket. Decanting asbestos troughs worn out
Rapid gravity sand filters	6 No	Status of lower gravel layer requires investigation. Sand blanket requires to be replenished
Potable water storage reservoirs	2 ground reservoirs	General maintenance required around these
